Subject: EPA Comments on MidAmerican Energy Co, George Neal North Power Station,
Sergeant Bluff, IA
Round 7 Draft Assessment Report

From: Jana Englander, OSWER, US EPA

Date: January 27, 2011

Walter Scott Energy Center Draft Report Comments

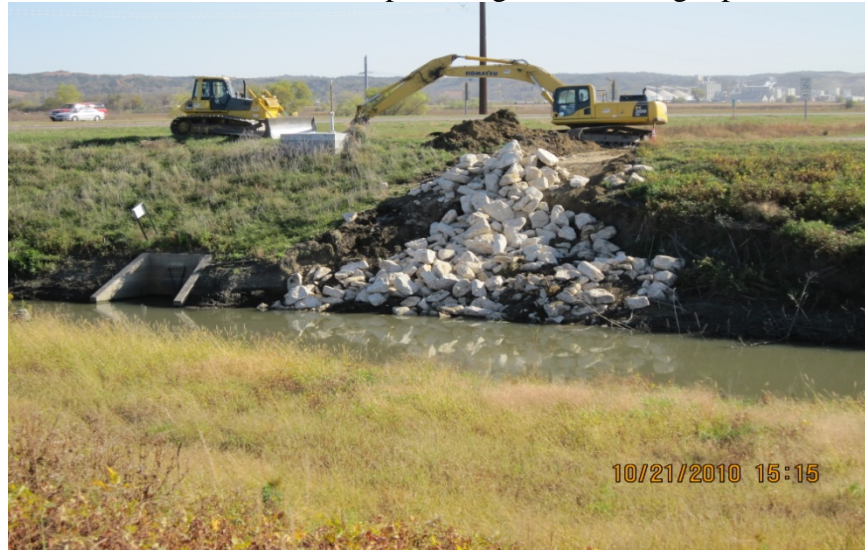
The draft report for this facility provides an assessment of **“Fair”** for both the South Surface Impoundment and the North Surface Impoundment. Pursuant to the report, the presence of sloughing on the levee side of the South Surface Impoundment and the need to further document the safety of the embankments under certain modes of failure were the primary contributors to this ranking. However, since the on-site inspection was conducted in September 2010, a great deal of work has been accomplished to specifically address these issues. As a result, MidAmerican respectfully requests that the ranking for both of these surface impoundments be changed to **“Satisfactory”** in the final report. The evidence to support this request is provided below.

Photo 1 - Levee District and Corps of Engineers starting repairs to slough

The Mills and Pottawattamie (M&P) Missouri River Levee District and the U.S. Army Corps of Engineers completed these repairs in February 2011 as shown in the photographs below. Large rip-rap was utilized to fill and stabilize the eroded portion of the levee, followed by a cover layer of soil and seeding.

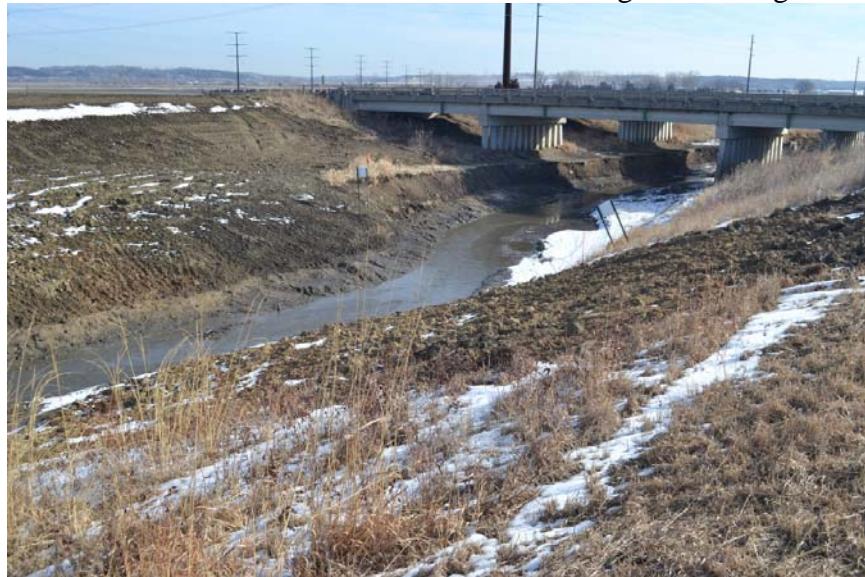
Photo 2 – Same area with final cover over slough area and graded

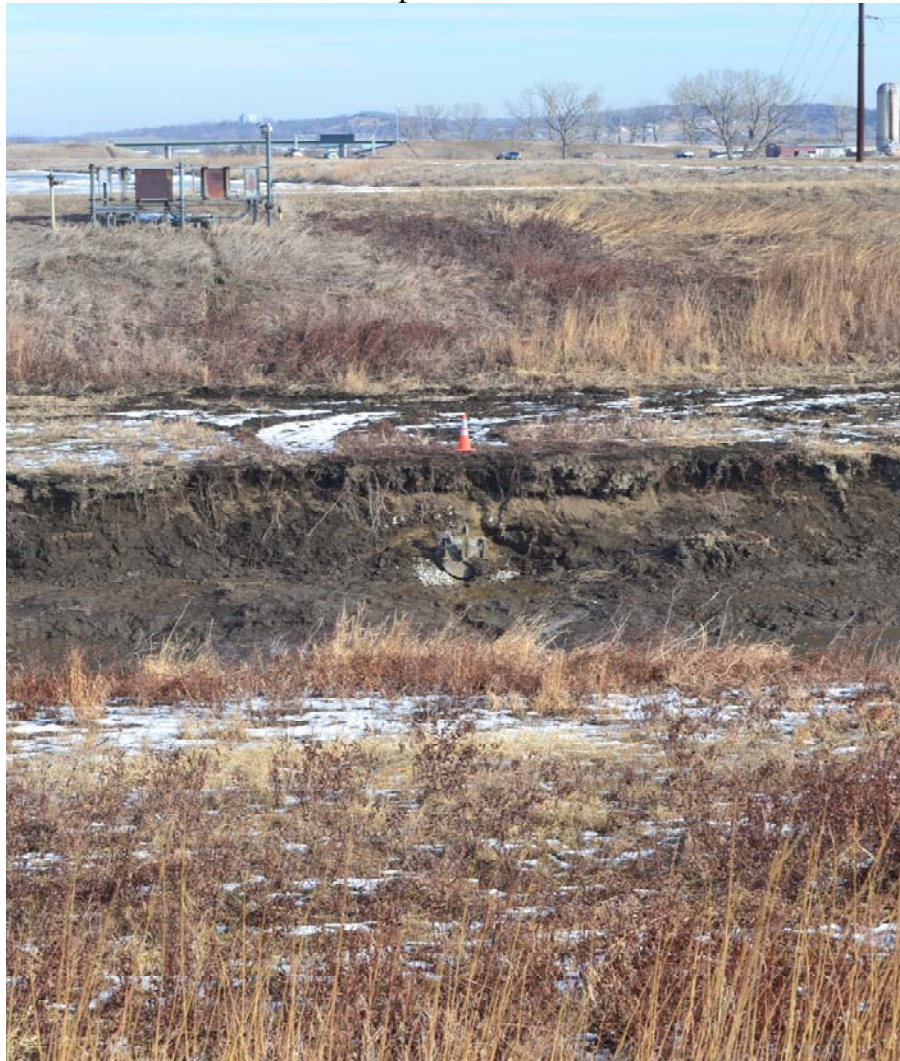
Photo 3 – Repaired outlet structure

Section 1.1.5: The report indicates that the damaged end of the outlet structure should be repaired to restore the structure to serviceable condition. The M&P Missouri River Levee District and Corps of Engineers are in the process of repairing these structures which were damaged by their previous subcontractor during straightening of the Pony Creek drainage way. Photograph 3 below shows the current status of the repairs. The photo was taken facing north showing the repaired discharge structure (located immediately below the orange cone) in the south bank of the North Surface Impoundment. This update also applies to section 1.2.5.

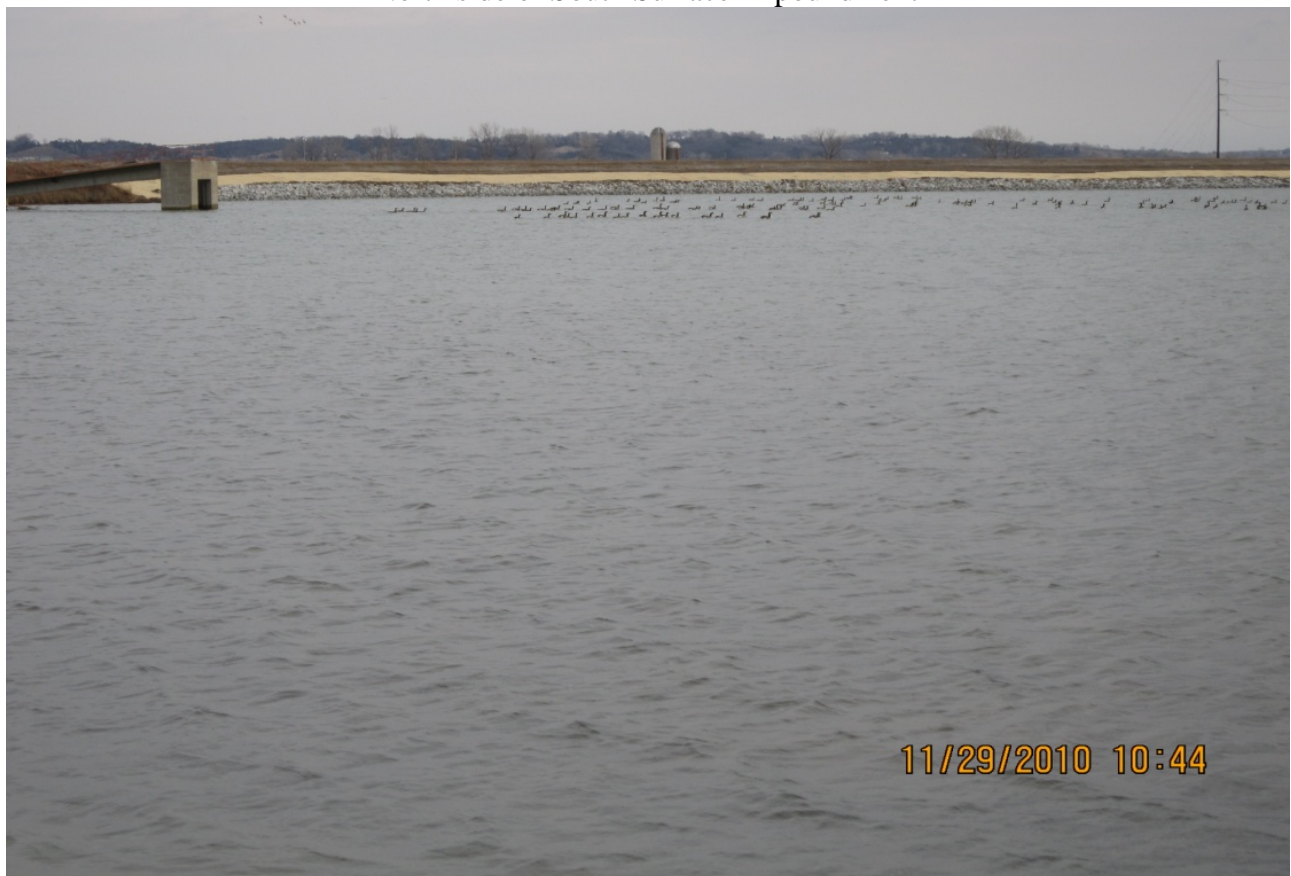
Photo 4 – Placed rip-rap to protect wave erosion action
North side of South Surface Impoundment

Section 1.2.6: The facility continues to make periodic inspections and repairs as necessary to address pond-side slope erosion caused by wave actions on the South Surface Impoundment on the north and south sides. The facility is also monitoring wave action on the northeast corner of the North Surface Impoundment and will make a further assessment on placement of rip rap for wave erosion protection in late spring 2011. Photographs 4-7 detail the repairs made to the South Surface Impoundment following the on-site inspection in September 2010.

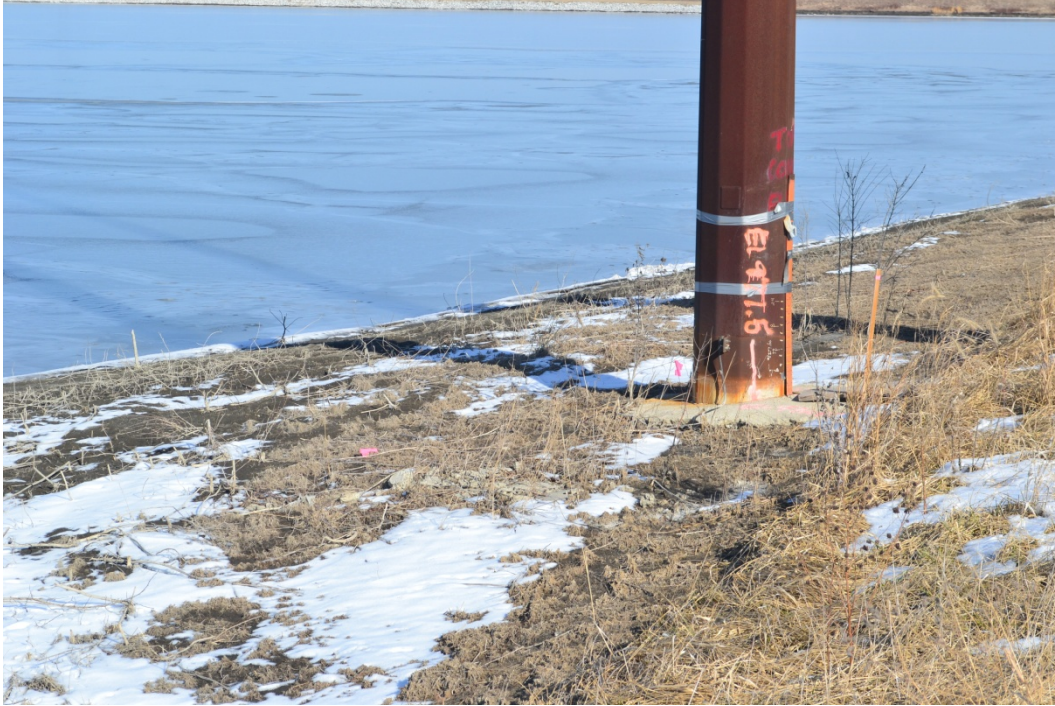
Photo 8 – Facing northwest showing southeast bank of South Surface Impoundment

Section 6.1.1: Please delete the phrase “Hearsay evidence from MidAmerican staff is that”, and replace it with “According to MidAmerican staff.” Additionally, the high water levels observed during the on-site inspection have in fact dropped considerably. At elevation 971.5’, the water level surrounded the base of the pole shown in Photograph 8. At that elevation there was still approximately 2’ of freeboard remaining to the lowest point on the levee structure. As can be seen in
